Outline Review of play and sports area off Canal Way, Ilminster

Commissioned by South Somerset District Council

November 2013

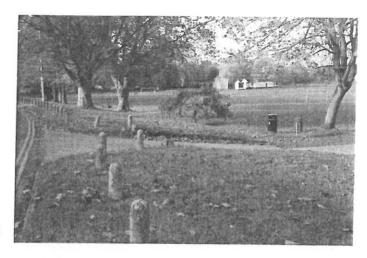
(photos above) and The Mead on the opposite side of the field (shown below). The main access ramp off Canal Way is 1.5metres wide and 15 metres long with a gradient of 5.9 deg (in excess of the 1:12 permitted). The further entrance ramp was 1.0 metre wide and 15 metres long with a gradient of 5.6 degrees (in

excess of the 1:12 permitted). There are no rest areas or handrails. BS8300 states that no ramp should exceed 10 metres in length without level rest areas and no ramp should exceed 4.7 deg (1 in 12) or exceed 2 metres in length at this gradient. The existing ramps are unsuitable for wheelchair users and children's pushchairs especially when wet or icy. The children's play area of the site is reasonably level and no special ramps or steps are necessary.
