Somerset County Council

Section 19 Investigation Report

Date of Incident:	20 th October 2021	Date of Report: 27th January 2023 Version: 5.0 Status: Final
Site / Catchment Location:	Ilminster

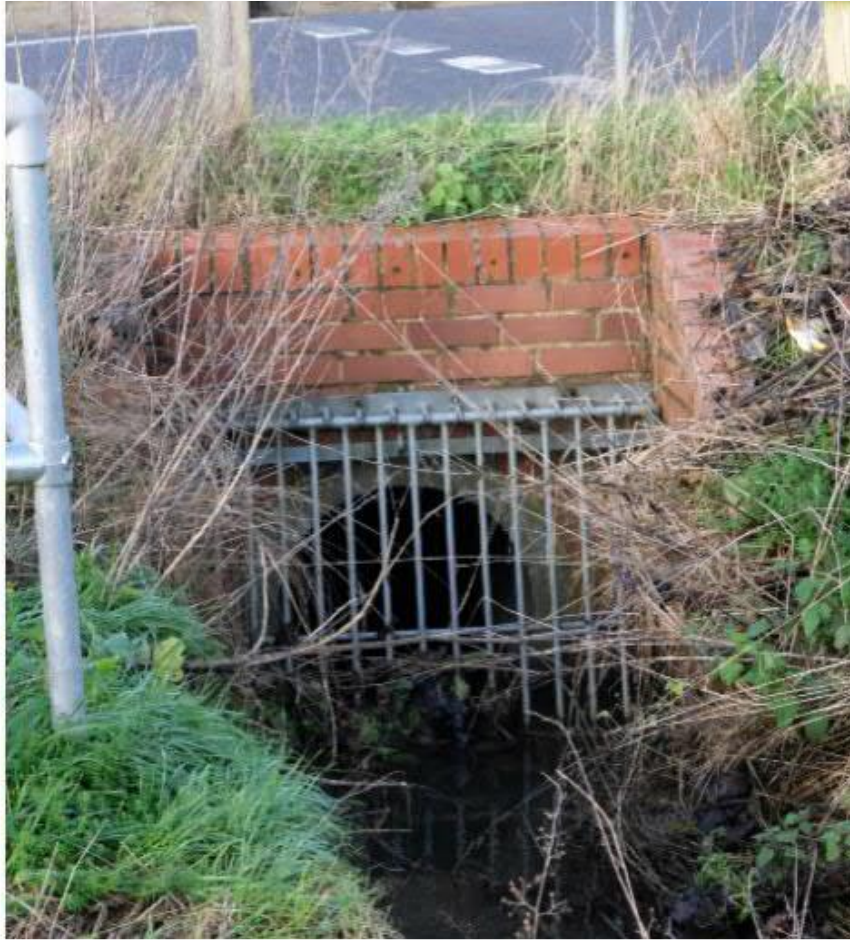
According to the reports of agencies out on the night, the flooding at Ditton Street was believed to be due to a combination of urban surface water, surface water coming off of land at the end of Shudrick Lane and the top of Listers Hill, and water spilling from the Shudrick Stream. Drains were reported by residents as being blocked. There have also been reports that ditches have not been cleared by land owners. The Shudrick stream runs along Shudrick Lane, and at one point enters a culvert, which feeds into a large drain running under the Tesco petrol station, and emerges in Abbots Close. The culvert appears to have been overwhelmed by the volume of water coming down the Shudrick Stream. If it had been blocked, we would expect to see more debris attached to the grate in front of the culvert in the photograph below. The overwhelming effect was supported by the testimony of a local resident, who said that he had never seen so much water coming down the Shudrick catchment into the culvert by Tesco, and that it appeared to overwhelm the stream and culvert, which then compounded the subsequent surface water flooding on Ditton Street. The culvert, at 600mm diameter, is comparatively undersized for a catchment from which it collects.

Figure 11: Culvert in Shudrick Lane, taken some time after the incident.

This section of the Shudrick Stream, including the culverted reach in question, is Main River and as such the EA is the flood risk management authority for this section. Under their permissive powers, they undertake periodic inspections of the culvert and channel. If there are significant concerns, and if they are able to, they exercise their powers to mitigate the situation. Ultimately the responsibility falls to the riparian owner. The EA's last culvert survey was undertaken in February 2017. This survey found no problems in the majority of the culvert from the inlet on down, but in the lower section (where it becomes an old masonry arch structure), there are two service pipes passing across the culvert, which pose a potential blockage risk. The pipes would be very difficult to remove, and at least one is currently in use for conveying sewage.

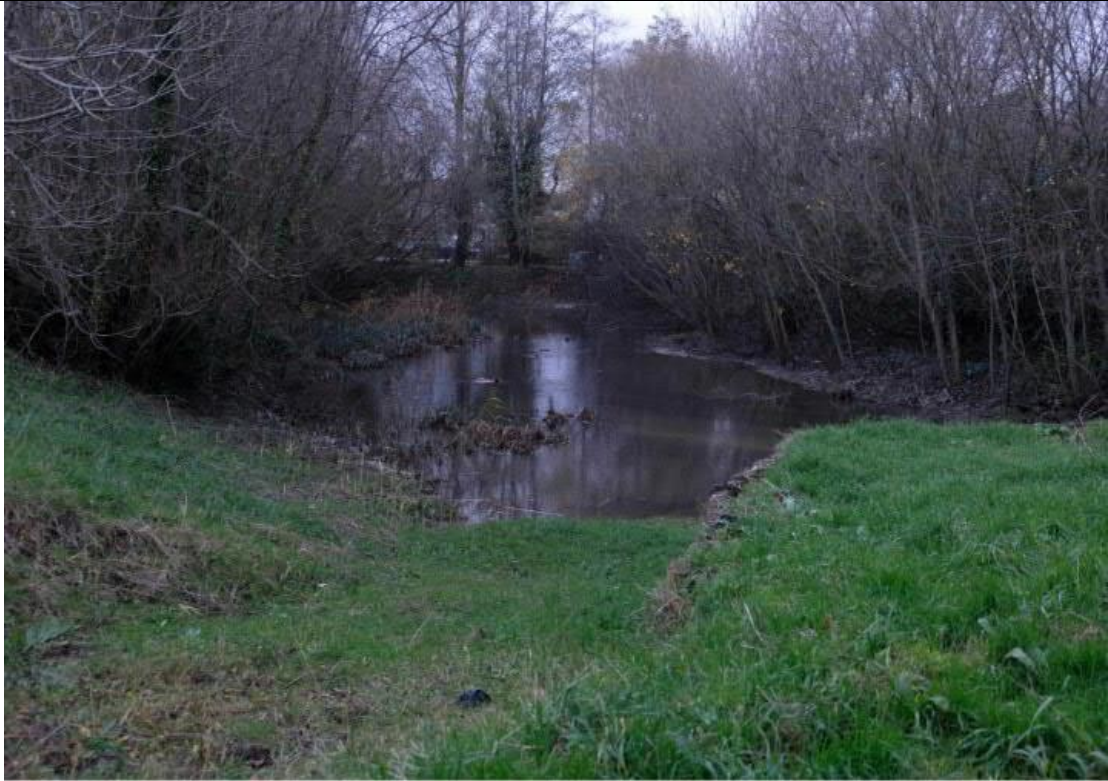
Figure 12: Storage area near Station Road. (Taken after flood waters had subsided)

Within the culvert, the Shudrick Stream then flows to the west under Ditton Street and Wharf Lane. Further downstream on the Shudrick the watercourse passes through a housing development in an open channel before flowing into a storage feature upstream of Station Road (as seen in Figure 12).

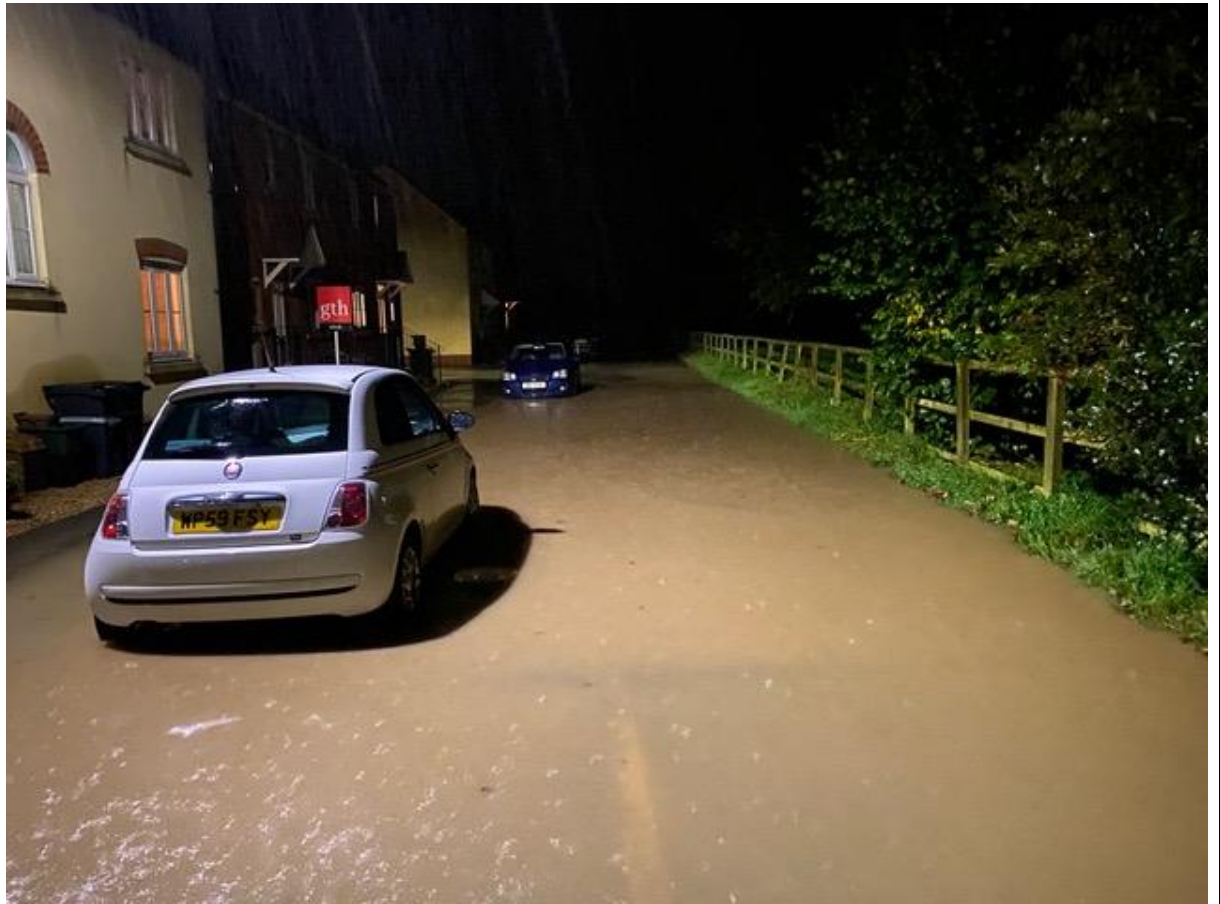
Figure 13: East end of Shudrick Lane at Walnut Close.

This photograph was taken close to where the road ends and the fields begin; the surface water floods down the road and into Ditton Street (which is half a metre lower than the top of the town culvert in Shudrick Lane) where it floods homes and shop premises. This roadway leads into fields where the area is in Flood Zone 2-3. On the right, on the other side of the wooden fence, is the Shudrick Stream.

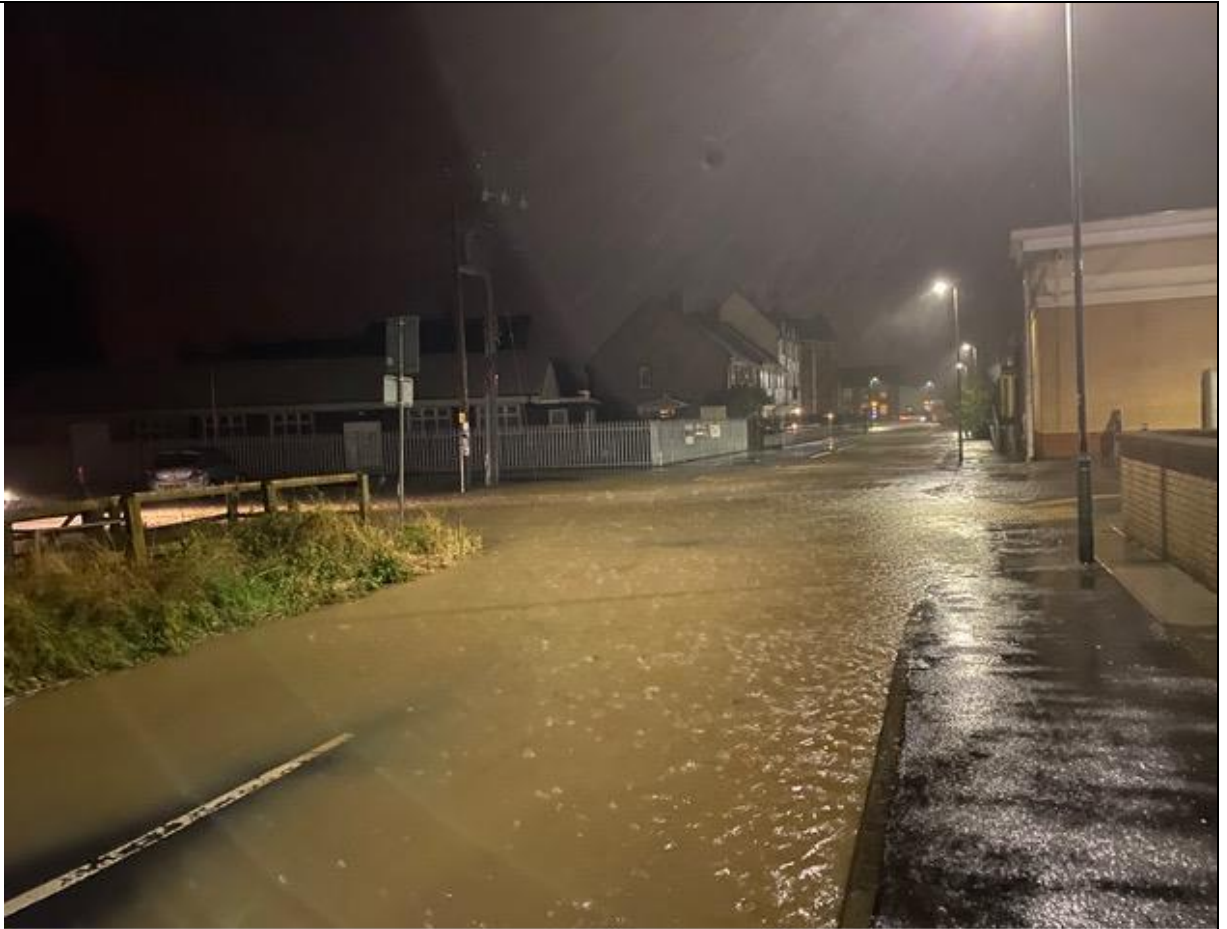
Figure 14: Looking west down Shudrick Lane.

Tesco car park is on the right, just outside of the photograph, and there is a small car park on left. Further to the left is the Swanmead school playing field, part of which also flooded. The entrance to the small car park, where the wooden fence ends, is the start of the town culvert on the Shudrick Stream.

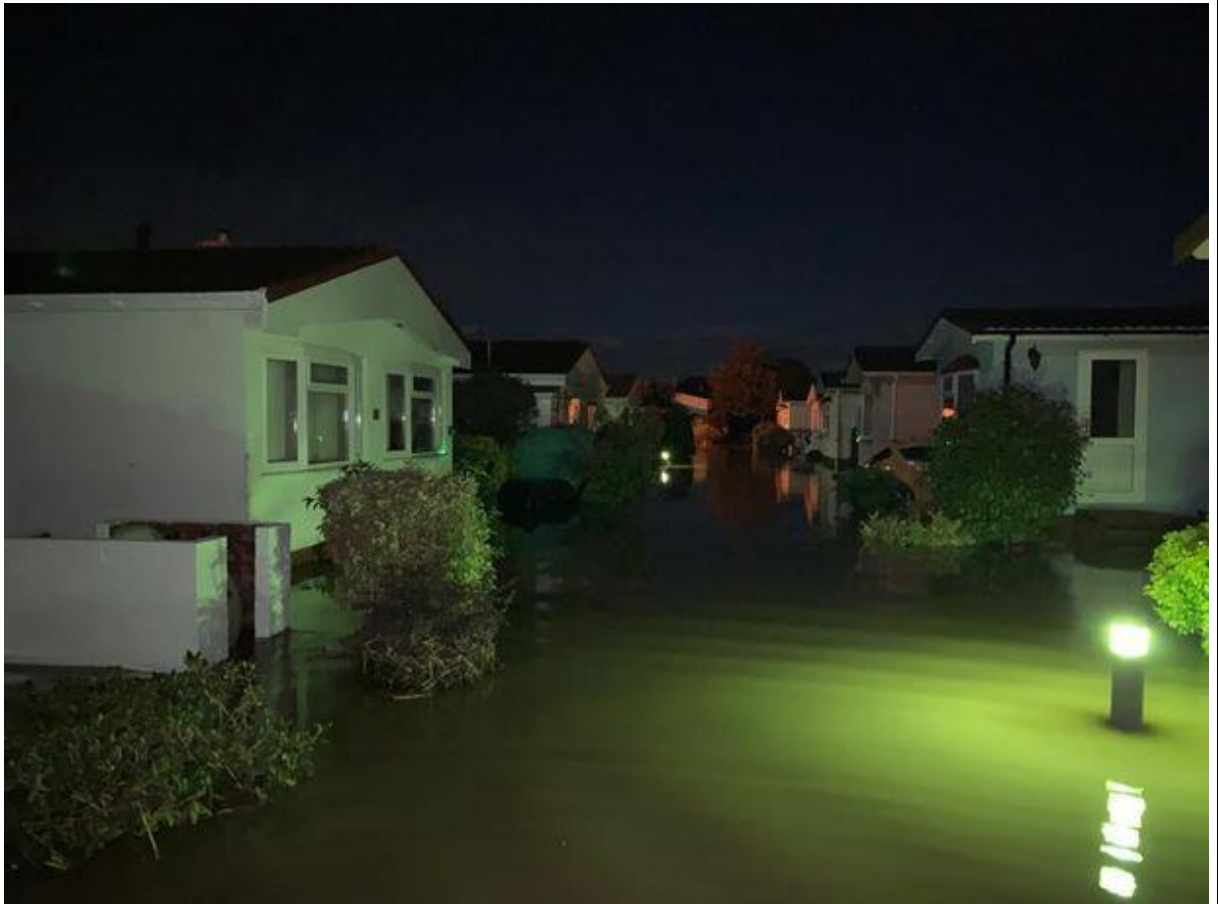
Figure 15: Holway House Park

Holway House Park was one of the worst affected areas with depths of water being described as up to 1.25 meters. Around 19 of the park homes were flooded internally, with nine being damaged beyond repair. A further 13 properties along Green Lane and three in Home Farm Way flooded with depths to around a metre. Thanks to its elevated ground level, none of the park homes in Home Farm Park were flooded internally, although there was external damage to garages and vehicles. There were an additional three commercial properties flooded in the Rose Mills Industrial Estate, which is on the left bank of the Isle upstream of Hort Bridge. From the damage witnessed in the buildings it was evident that there were water depths of up to 10 centimetres.

There is a network of small drainage ditches around the park homes, Home Farm, and the old station, which overflowed on the night. Ownership and responsibility for these assets is not definitively known, but is probably riparian. Residents feel that the flooding would have been contributed to because they have not been maintained. There is also a cattle grid which was installed to catch field runoff. Residents reported that water was overflowing from the cattle grid and contributing to flooding.

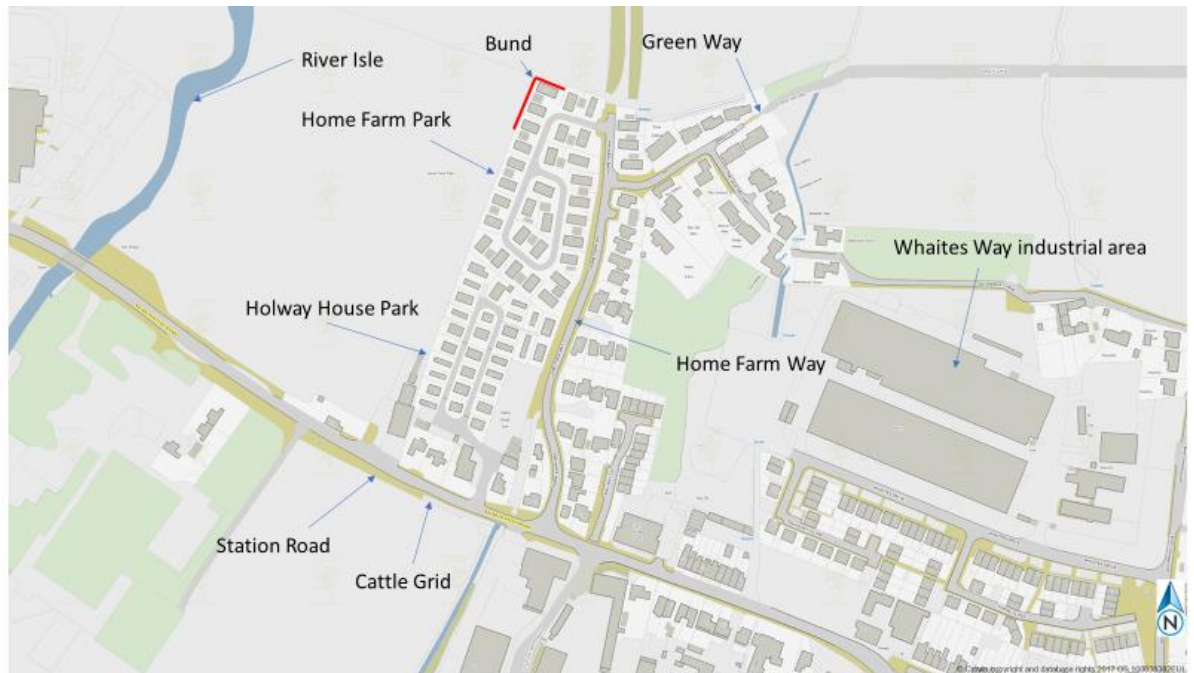
Within the residents' testimony of the flooding to Home Farm Park and Holway Park there were many references to 'the bund behind Home Farm Park'. Investigation has revealed some of the history and detail of this bund, and a cattle grid installed around the same time on Station Road.

FIGURE 20: BUND LOCATION.

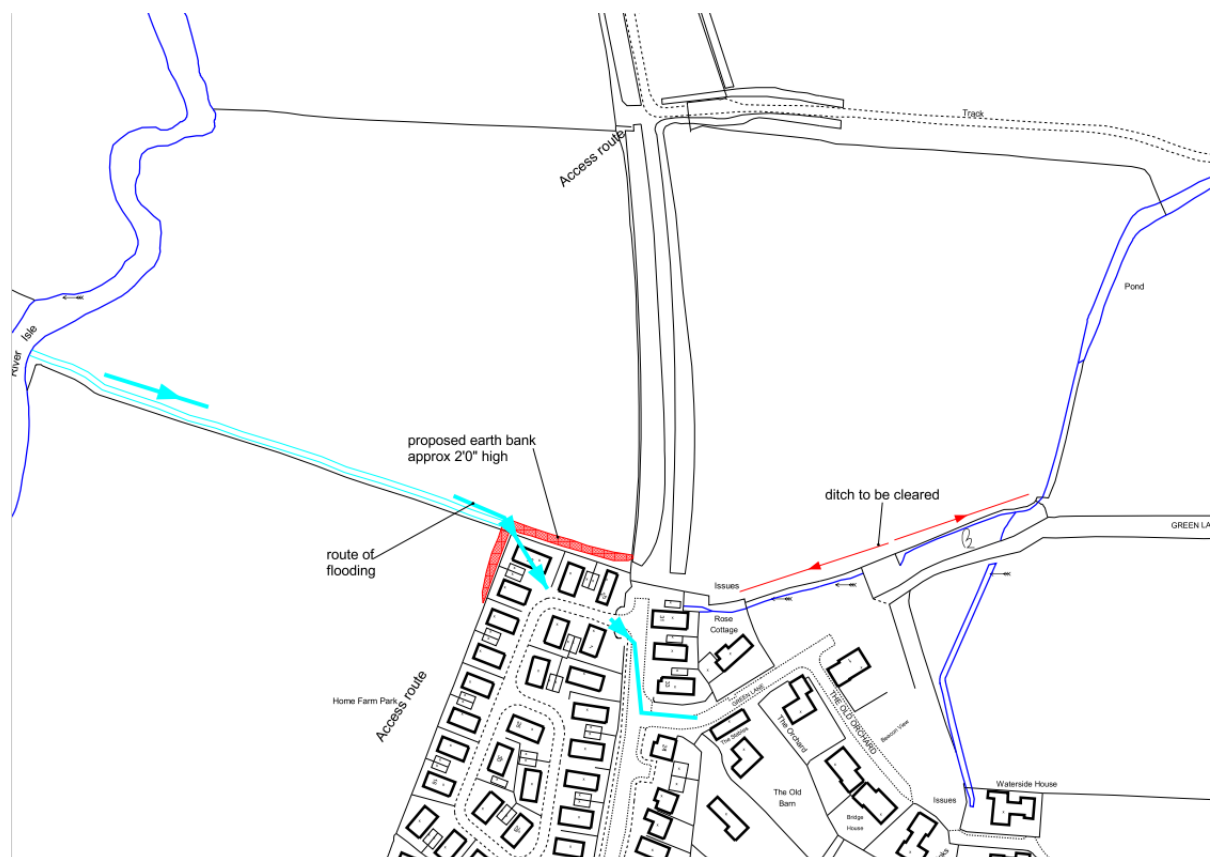
Figure 24: Design records for Bund around Home Farm Park, SSDC.

Reports from residents as to the current state of the bund and the reason for it vary. Some maintain that the bund has degraded and been flattened, others that it is intact. Some maintain that an increase in size of the gardens of some of the Park Homes has intruded into the bund, some that annual ploughing of the Dairygold

<p>field has caused problems. A survey of the bund needs to be undertaken as part of re-instatement and/or improvement works. It may be better, rather than try and restore the bund to an original condition of unknown resilience, to ascertain what design parameter we wish to use and rebuild to that standard.</p>
<p>Rainfall Information:</p>	<p>There was very heavy rain on the 20th and 21st of October, on the back of previous heavy rain saturating the catchment.</p> <p>The amount of rain, which the Environment Agency estimate at around 62 millimetres in 24 hours, was 71% of the monthly average, just in that 24-hour period.</p> <p>The nearest river gauge is at Donyatt, which is just upstream of Ilminster. This gauge is used by the Environment Agency to predict flooding and issue flood warnings for the main river Isle. On the 20th of October, this gauge returned the record highest level for the river Isle, over the gauges 30-year history.</p> <p>Below is an excerpt from EA Monthly water situation report for Wessex:</p> <p>“October was a wet month for Wessex, with ‘above normal’ rainfall at 187% of the LTA (149 mm). There was light rain at times throughout the month, but the main rainfall events occurred on 1 – 4, 19 – 20 and 28 – 31 October which combined produced around 90% of the month’s total rain. The highest accumulation was on 19 and 20 October when 33% of the month’s rain fell, distributed across most of Wessex.”</p>

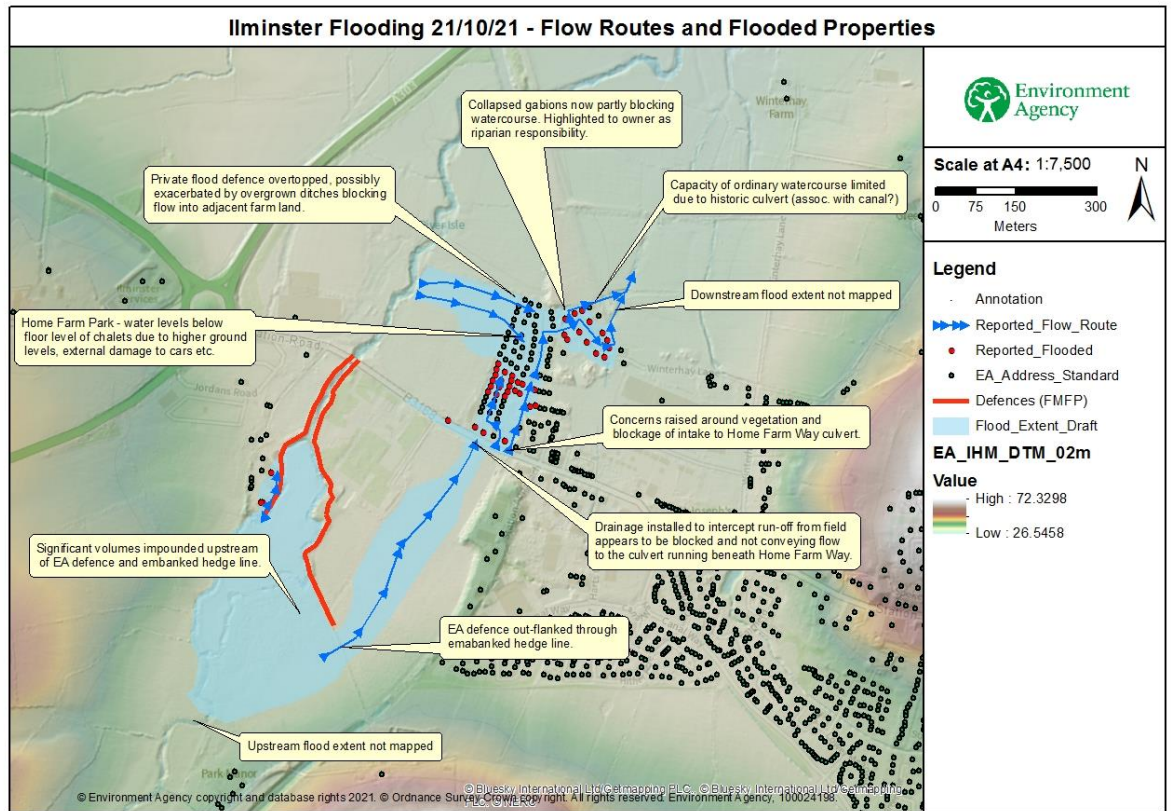
Figure 29: Flow paths at the west end of Iminster. Source: Environment Agency, November 2021.

The information in this map represents an outline estimate of the flood mechanisms and flooded properties during the flood of 20/21 October 2021 on the west side of Iminster. It is based on information gathered in the aftermath of the flood and may not be a complete and accurate summary, but is based on the best data and resource available at the time.

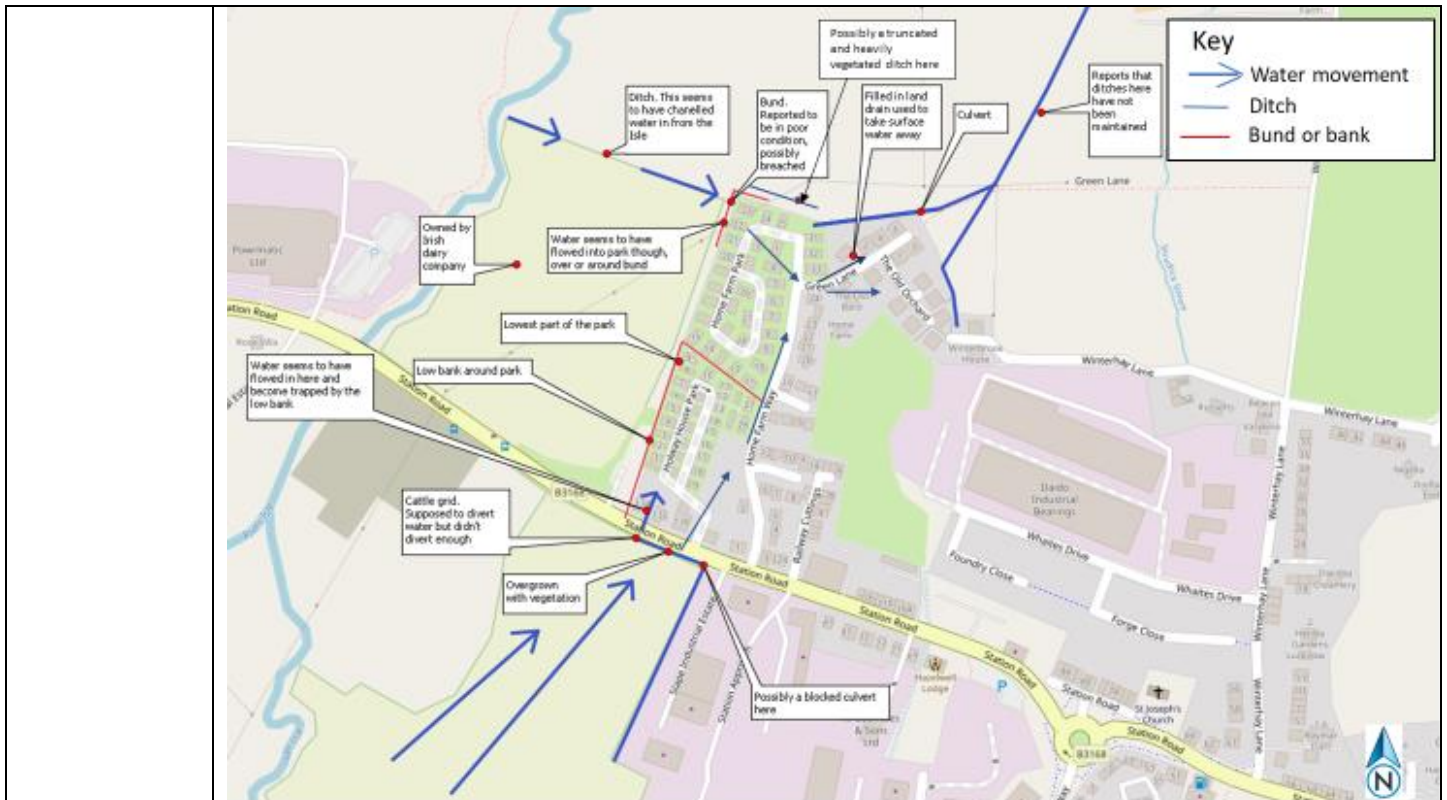
Figure 30: Further detail of west Ilminster

Most of the volume of water has come from the river Isle. The river spilled over its banks both to the north of the Hort bridge, and around the flood defences to the south of the bridge. Water from the northern spill flowed up over the field, to the west of Home Farm Park. From here it flowed through, around and/or over the bund into Home Farm Park, and across into Green Lane. Water coming up from the south combined with pluvial flow across the fields, flowed into and over the cattle grid, and across Station Road into Holway House Park and the houses next to it. This water was trapped in situ by the low bank around the park. Another portion of the water that came up from the south flowed across Station Road and across into Home Farm Way. This flowed down Home Farm Way to join up with the water from the north in Green Lane and the Old Orchard.

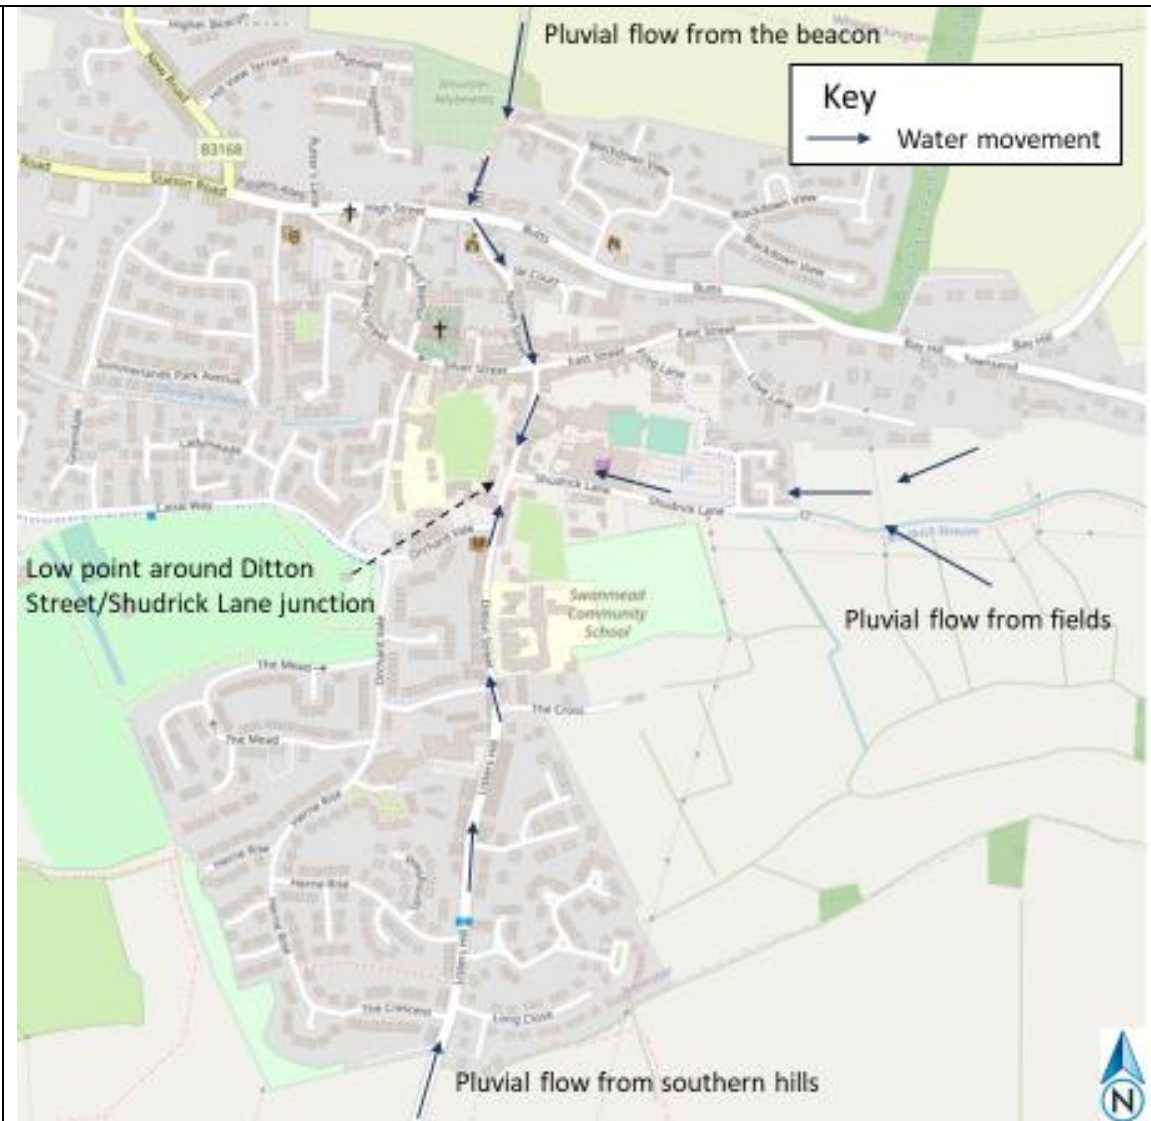
Pluvial flow from the hills to the north and south of Ilminster flowed down into the centre of town and gathered in the low spot at the junction of Ditton Street and Shudrick lane. Flow from the north came from Beacon hill, down the track past the allotments, along Old Road and into North Street. Water heading into town from the south flowed down Listers Hill and into Ditton Street. Rainwater also flowed in from the fields to the east of Ilminster and down Shudrick Lane, where it again collected at the low point. This was added to by water from the Shudrick Stream itself, which came out of bank, possibly due to the culvert that leads under Ditton Street becoming blinded with debris or overwhelmed by the large quantity of water.

EA, local residents and Councillors observed these flow paths, and also that the pluvial flow comes off fields, carrying soil, stones, and debris with it. This will tend to collect in and possibly block drains during an event. Long term local residents also observed the high volumes of water coming from these sources, and said that they felt even free running drains would not have coped with all of it.

Figure 31: Pluvial flows around east Ilminster
