Somerset County Council

Section 19 Investigation Report

Date of Incident:	20 th October 2021	Date of Report: 27th January 2023 Version: 5.0 Status: Final
Site / Catchment Location:	Ilminster

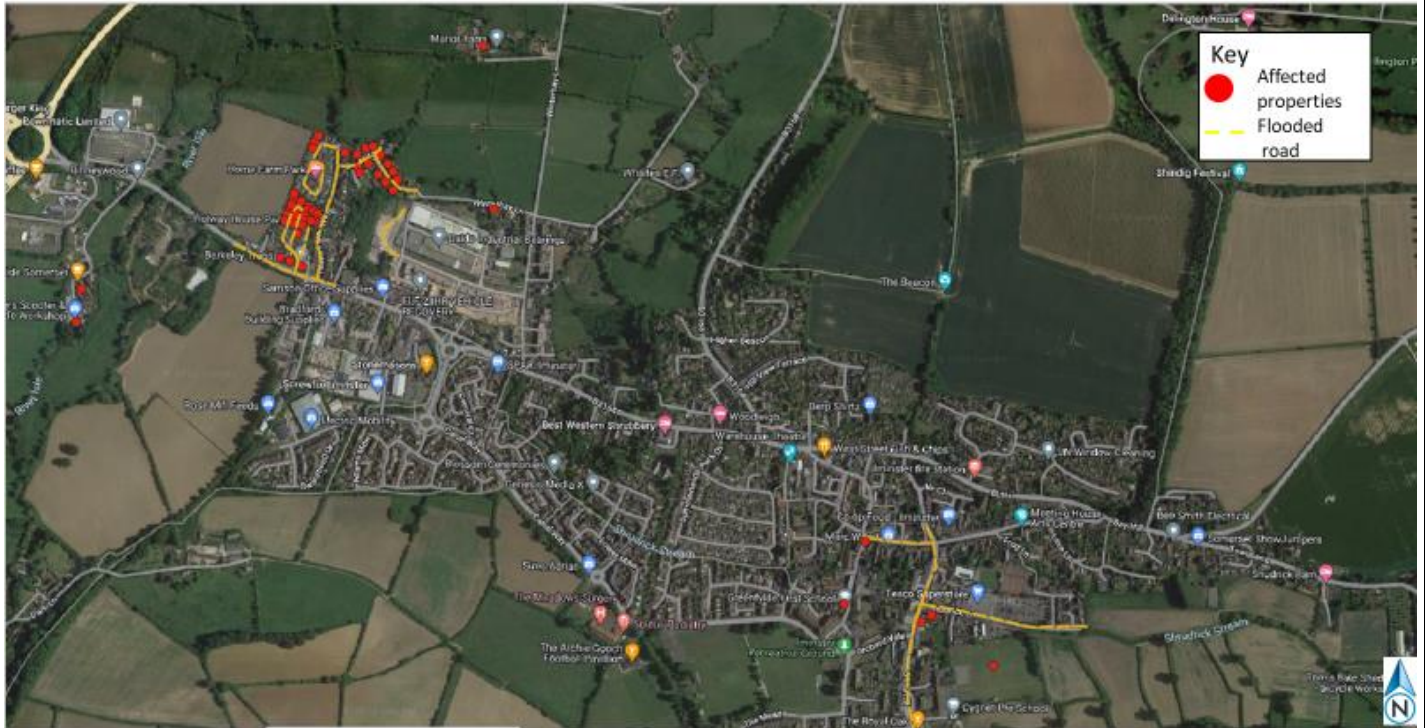
Figure 6: Areas affected in Ilminster

50 properties have been reported as flooding in Ilminster during the event. The actual number affected may be higher, as those affected sometimes do not report having been flooded.

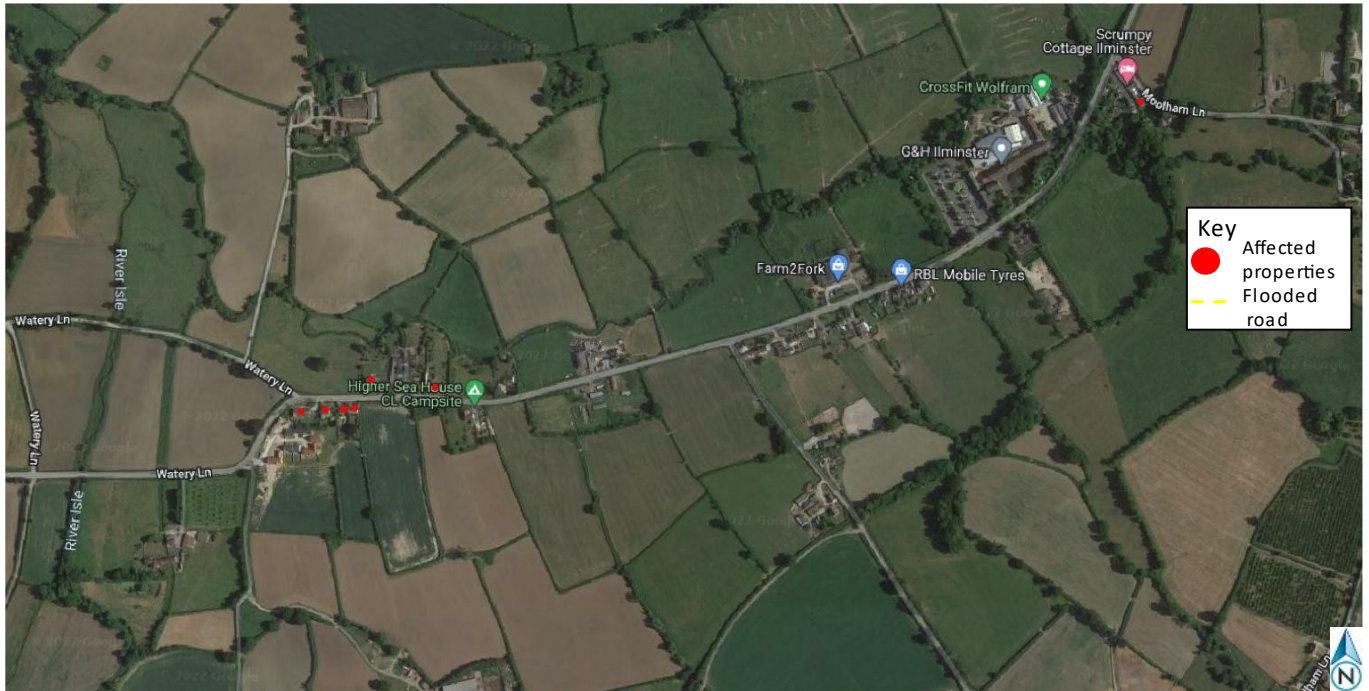
Figure 7: Areas affected in Sea and Dowlish Ford

Six Properties were reported as being affected by flooding in Sea, and one in Dowlish Ford.

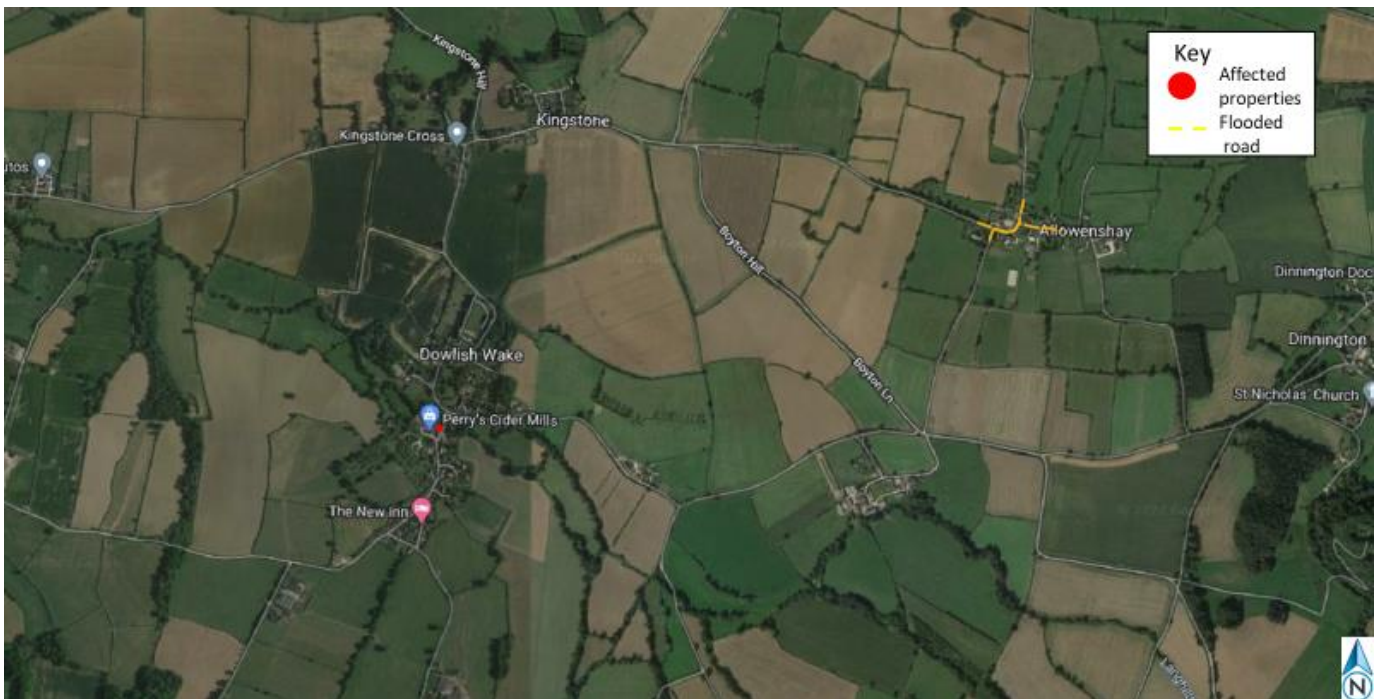
Figure 8: Areas affected in Allowenshay and Dowlish Wake

One property was reported as being affected in Dowlish Wake. Roads were flooded in Allowenshay. Horton Village was also reported as being badly affected, but no details have been received.

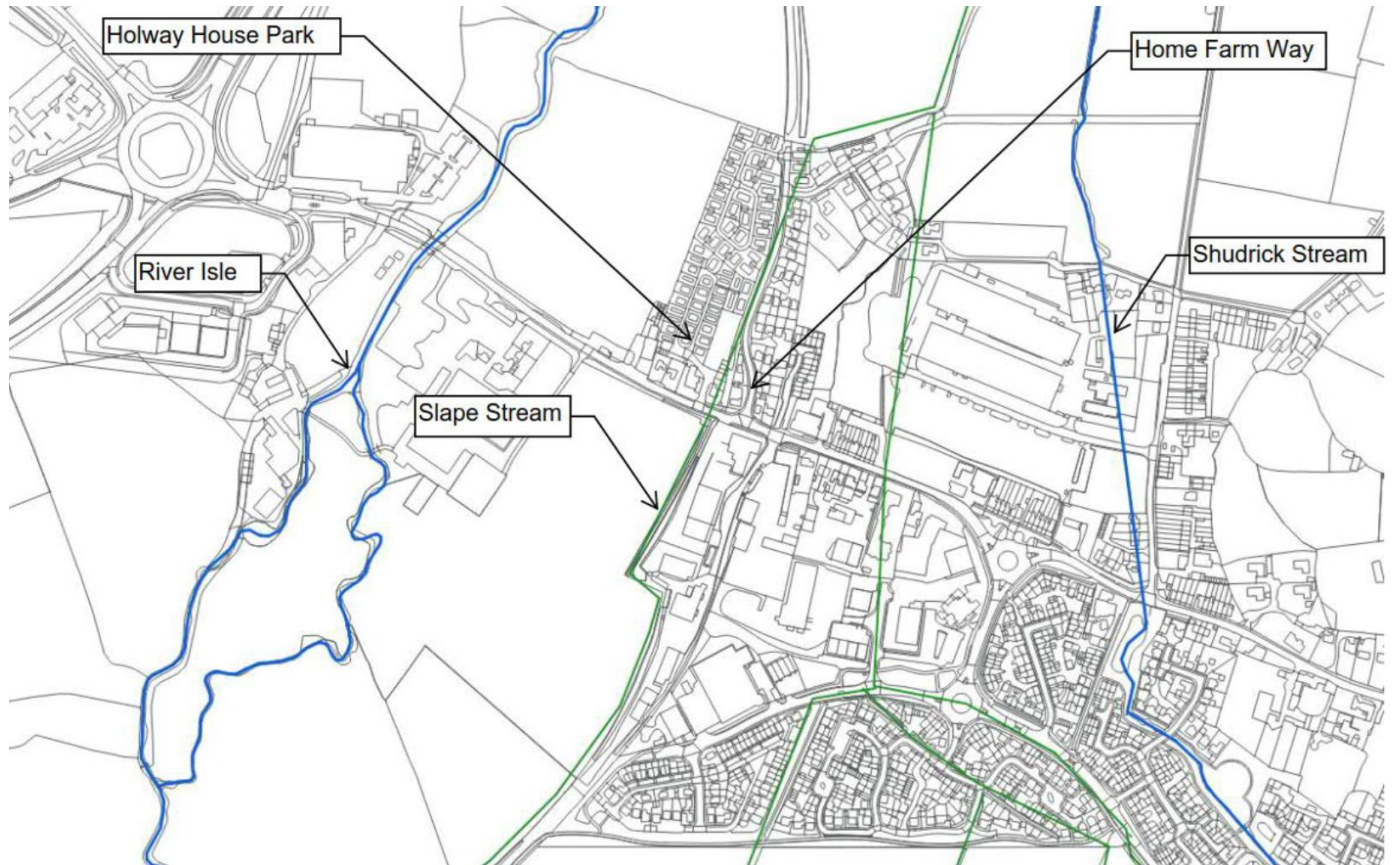
Figure 9: Watercourses around the Park Home sites

Both Holway House Park and Home Farm Park park home sites were particularly impacted. Houses in Station Road, Green Way and Home Farm Way, and the industrial area around Whites Drive also experienced flooding.

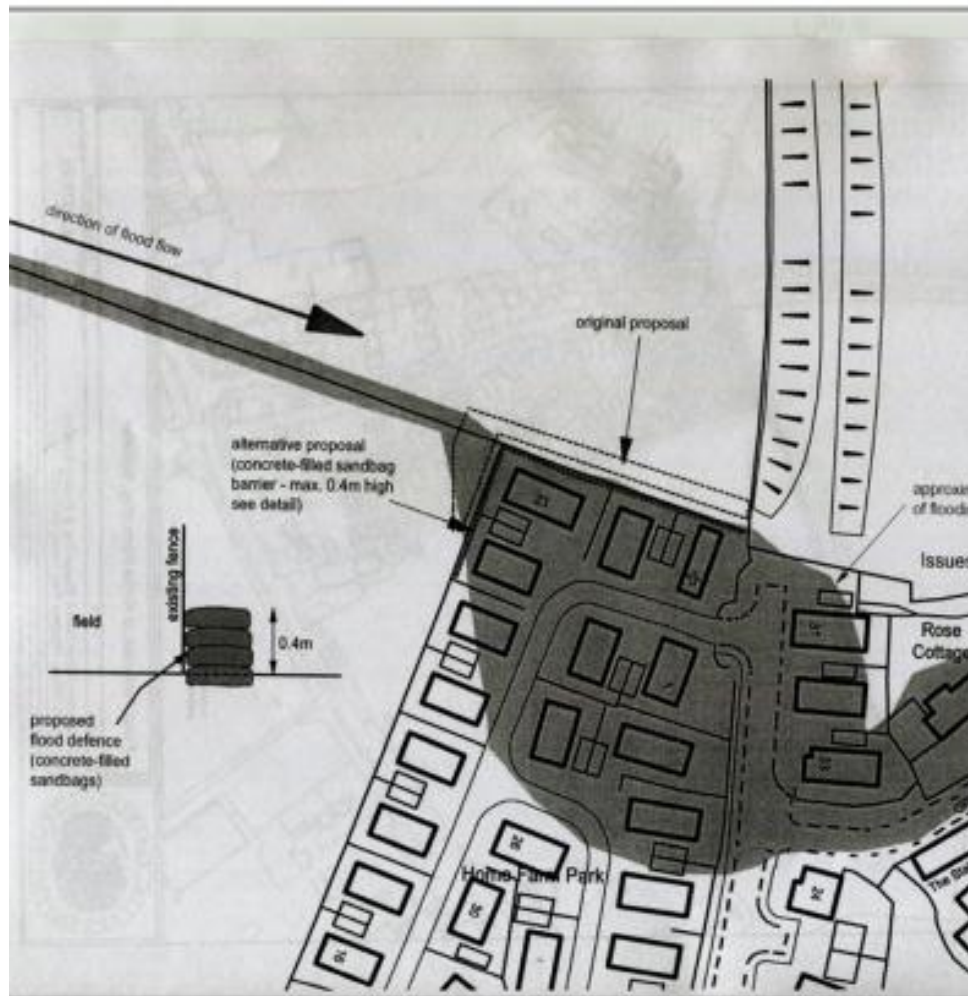
Figure 21: Proposed bunds at the back of Home Farm Park.

A copy form has been found, dated 26th June 2013, which details the application by Ilminster Town Council and the West Ilminster Flood Mitigation Group (made up mostly of residents of Holway House Park and Station Road). This form details the proposal to construct a bund, at the back of the north most corner of Home Farm Park, and a cattle grid and ditch along Station Road, as shown in the following maps:

The deep grey area shows the area flooded in 2008.

Reports from residents as to the current state of the bund and the reason for it vary. Some maintain that the bund has degraded and been flattened, others that it is intact. Some maintain that an increase in size of the gardens of some of the Park Homes has intruded into the bund, some that annual ploughing of the Dairygold

<p>field has caused problems. A survey of the bund needs to be undertaken as part of re-instatement and/or improvement works. It may be better, rather than try and restore the bund to an original condition of unknown resilience, to ascertain what design parameter we wish to use and rebuild to that standard.</p>
<p>Rainfall Information:</p>	<p>There was very heavy rain on the 20th and 21st of October, on the back of previous heavy rain saturating the catchment.</p> <p>The amount of rain, which the Environment Agency estimate at around 62 millimetres in 24 hours, was 71% of the monthly average, just in that 24-hour period.</p> <p>The nearest river gauge is at Donyatt, which is just upstream of Ilminster. This gauge is used by the Environment Agency to predict flooding and issue flood warnings for the main river Isle. On the 20th of October, this gauge returned the record highest level for the river Isle, over the gauges 30-year history.</p> <p>Below is an excerpt from EA Monthly water situation report for Wessex:</p> <p>“October was a wet month for Wessex, with ‘above normal’ rainfall at 187% of the LTA (149 mm). There was light rain at times throughout the month, but the main rainfall events occurred on 1 – 4, 19 – 20 and 28 – 31 October which combined produced around 90% of the month’s total rain. The highest accumulation was on 19 and 20 October when 33% of the month’s rain fell, distributed across most of Wessex.”</p>

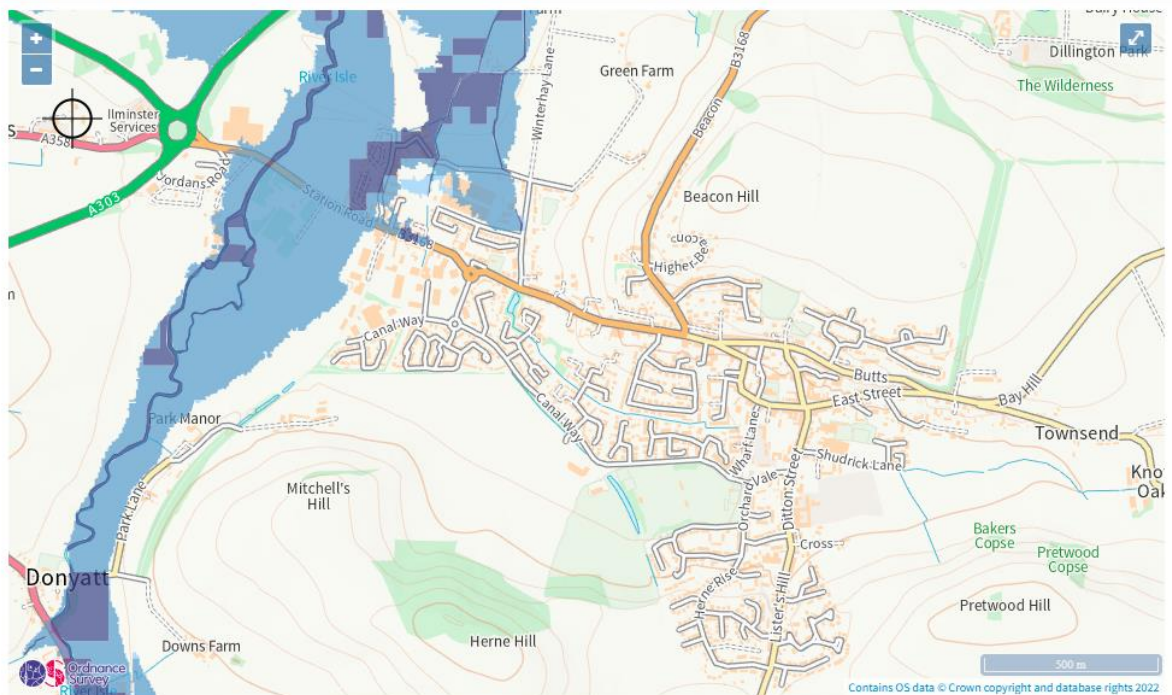
Figure 27: Fluvial flood risk Ilminster

The western side of Ilminster was particularly badly affected by fluvial flooding from the River Isle. The river appears to have bypassed the Environment Agency flood defences upstream of the Hort bridge and spread out over the old Dairygold site and fields next to the river. It then entered the two park homes sites and surrounding roads, both from the east and from the south, as water ran across Station Road, as shown in figure 27. It also affected the Rose Mill Industrial estate on the Horton Cross side of the river.

The nearest fluvial gauge is at Donyatt. The highest level recorded at this gauge during the incident was 2.649m on the 20th of October. This had dropped slightly to a high of 2.608m the following day. This is not the highest this gauge has ever recorded: 3.91m was recorded on 16th March 2013 and 4.11m on 17th March 2014. This is from riverlevels.co.uk, where the records only go back as far as January 2013.
